# Removal and monitoring of Himalayan Balsam *Impatiens glandulifera*

## - Monitoring Report

### Action C10

**LIFE09 NAT/IE/000220 BLACKWATER SAMOK**

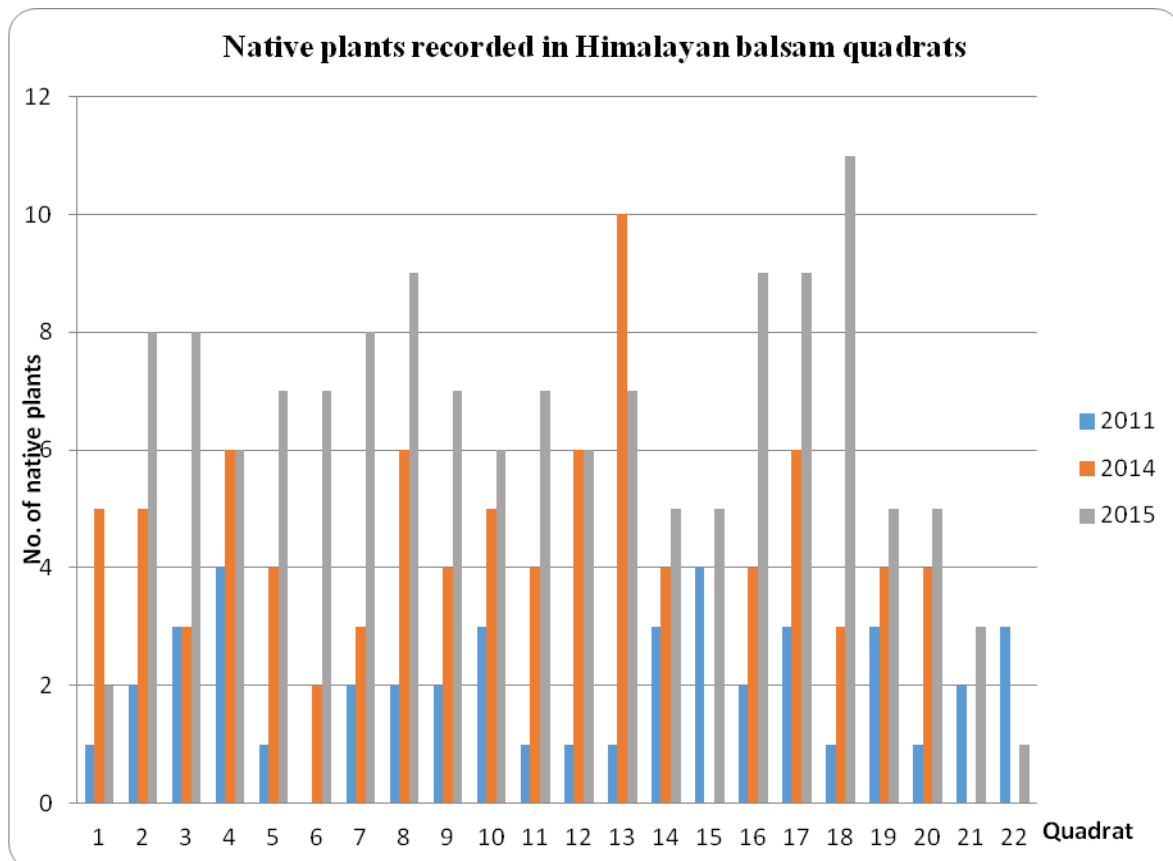
Figure 4 Native species richness recorded within 22 quadrats along the Allow River. Species recorded in 2011 are pre-management of *I. glandulifera*. Note: Quadrats 15, 21 and 22 were not surveyed in 2014 due to inaccessibility at the time of surveying.

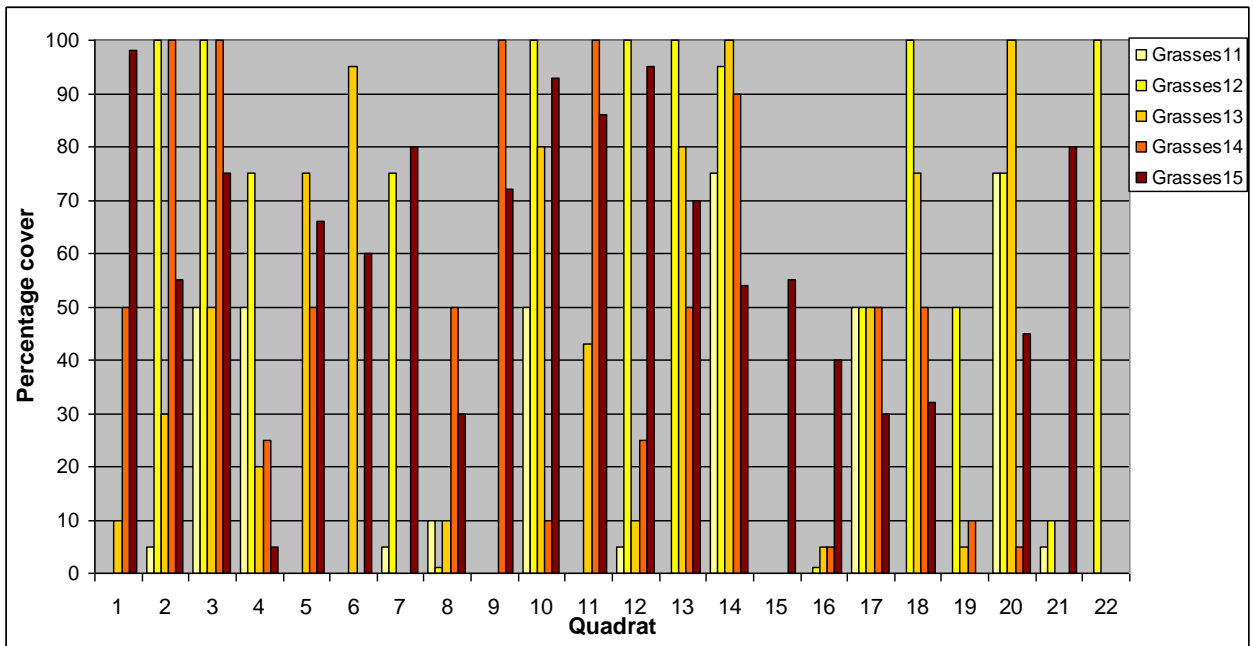
Figure 5 Percentage cover of grasses in monitoring quadrats 2011-2015

When the average percentage cover values for grasses and herbaceous species are separated, there is some indication of a fluctuation in cover between these two groups from 2012 to 2015. The data indicate that grasses responded most strongly to *I. glandulifera* removal in the first year, with a proportionally high average percentage cover (71%) when compared with broadleaved herbaceous species (41%). In subsequent years the proportion of grasses to herbs was roughly equal.

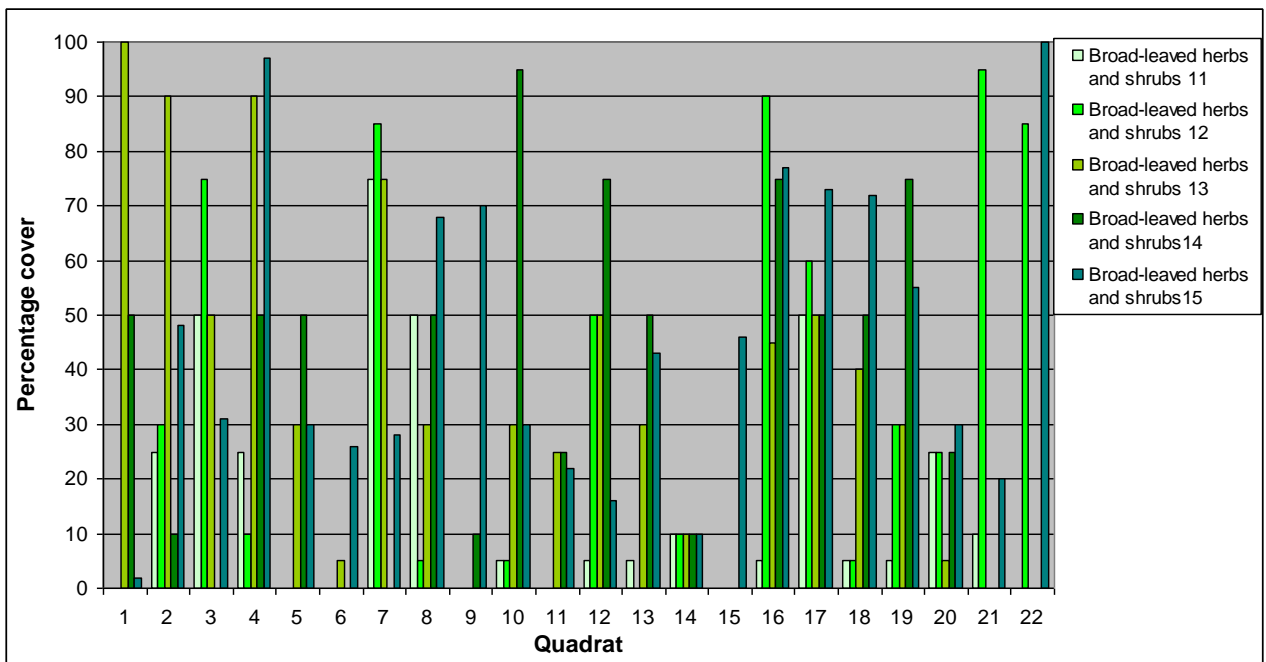
Figure 6 Percentage cover of broadleaved herbaceous species and shrub species in monitoring quadrats, 2011-2015

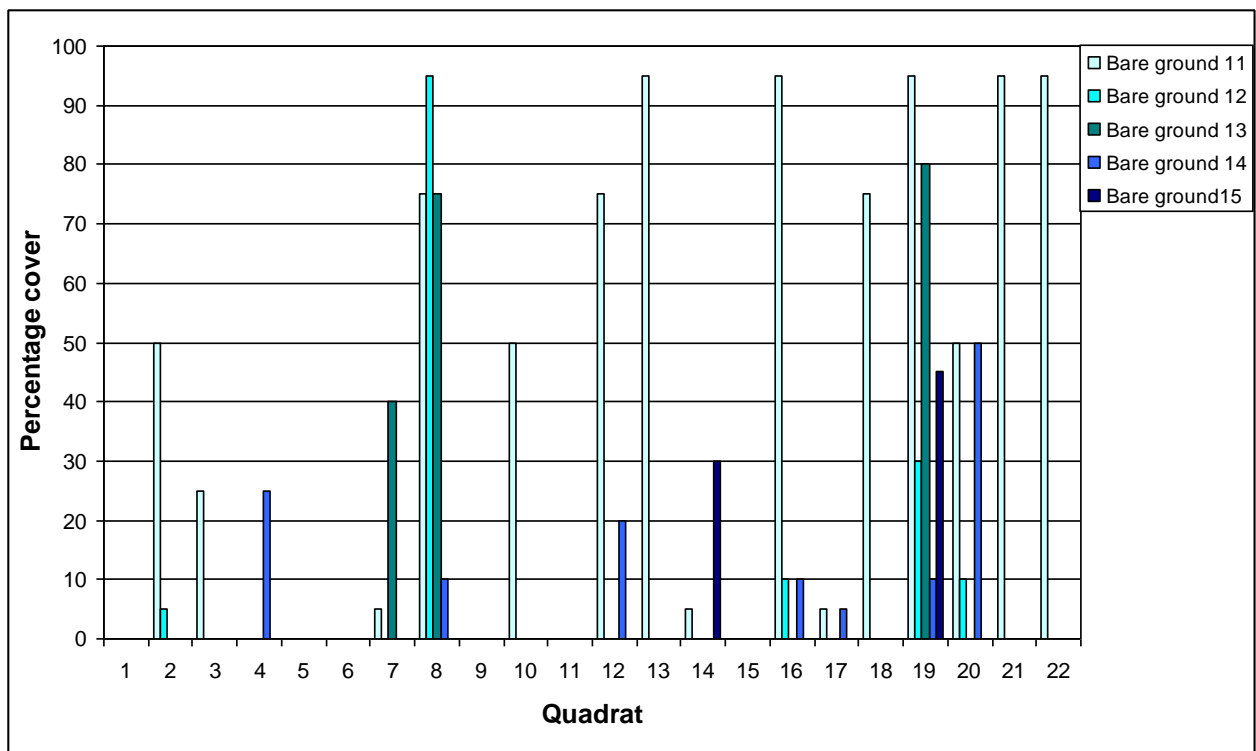
Figure 7 Percentage cover of bare ground in monitoring quadrats, 2011-2015

Shaded habitats were slower to respond to the removal of *I. glandulifera*, where the high proportion of bare ground can be at least partly attributed to the low light conditions and, in some cases, grazing and poaching by livestock.

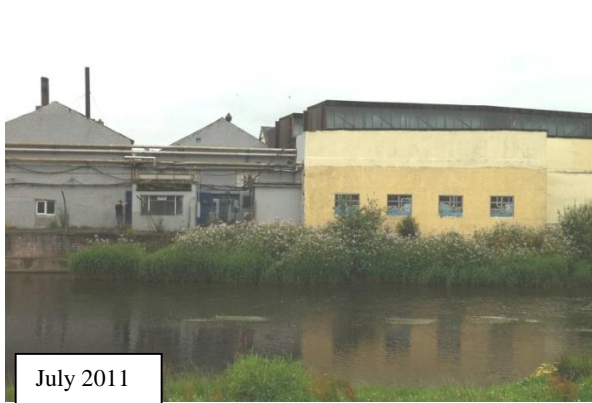
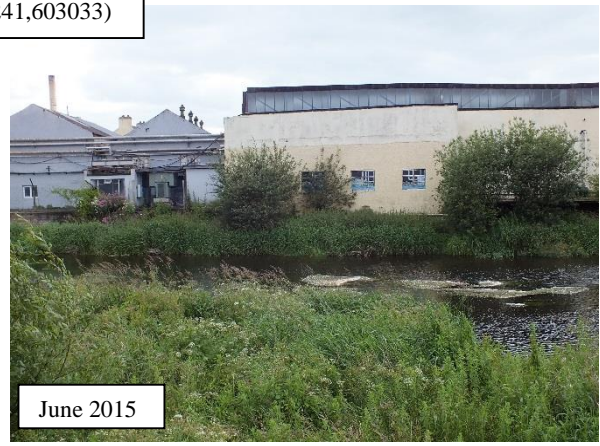
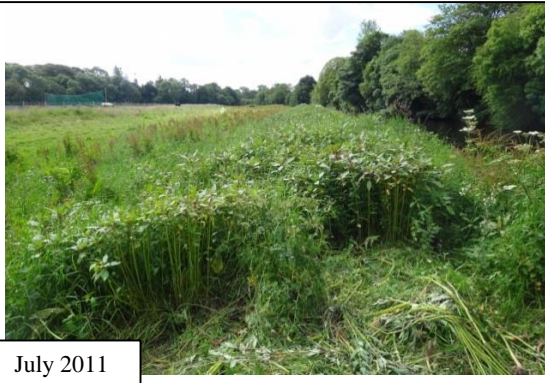
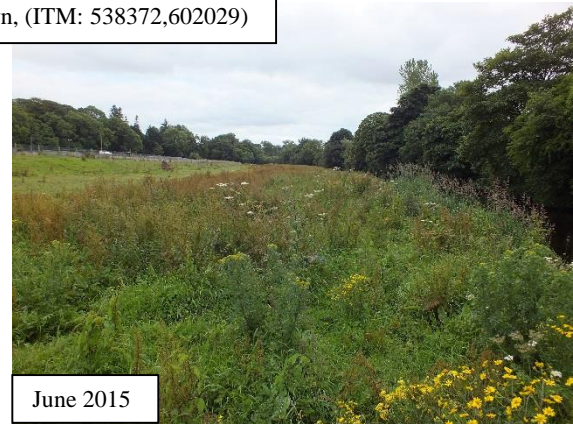
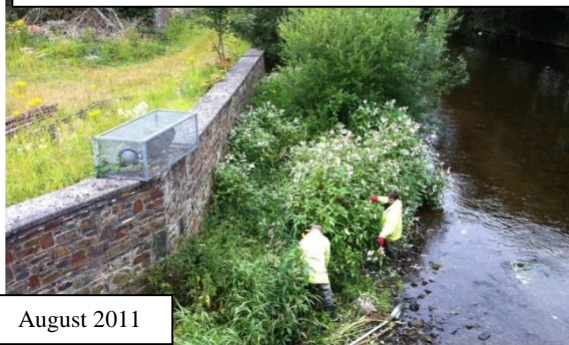
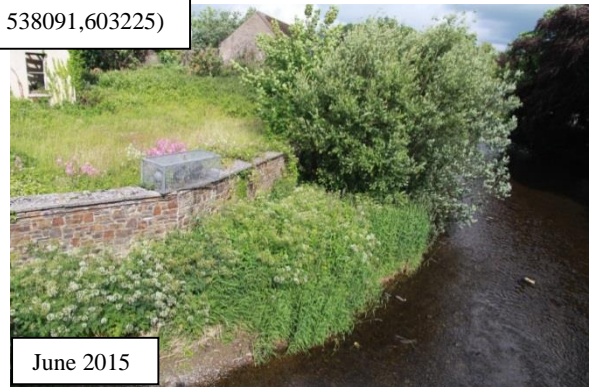
Figure 8 Before and after photographic evidence of successful Himalayan balsam management along the Allow and Dalua Rivers

Location: River Allow, Creamery, Kanturk town, (ITM: 538241,603033)

Location: River Allow, Adjacent to soccer field, Kanturk town, (ITM: 538372,602029)

Location: River Dalua, Dalua Bridge, Kanturk town, (ITM: 538091,603225)

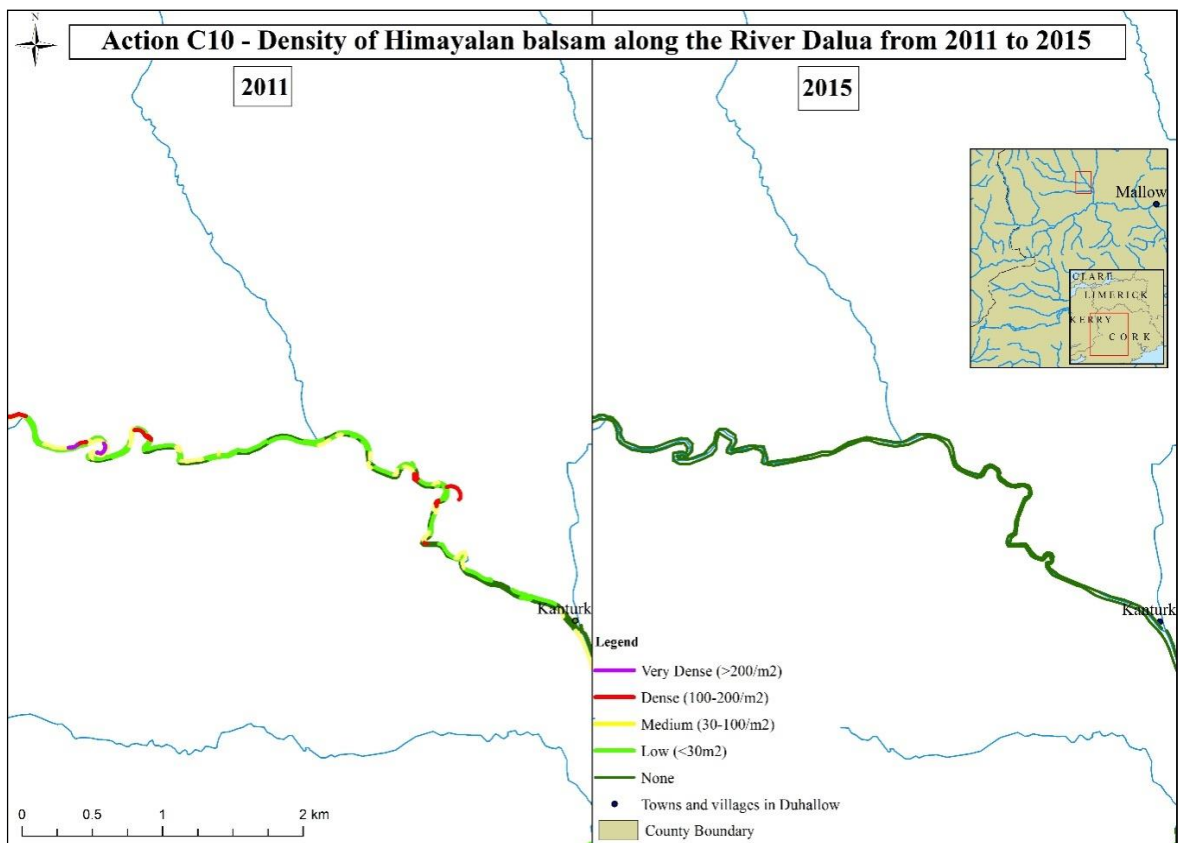
Figure 10 Distribution and densities (mean number of plants/m<sup>2</sup>) of *I. glandulifera* along the River Dalua in 2011 and 2015

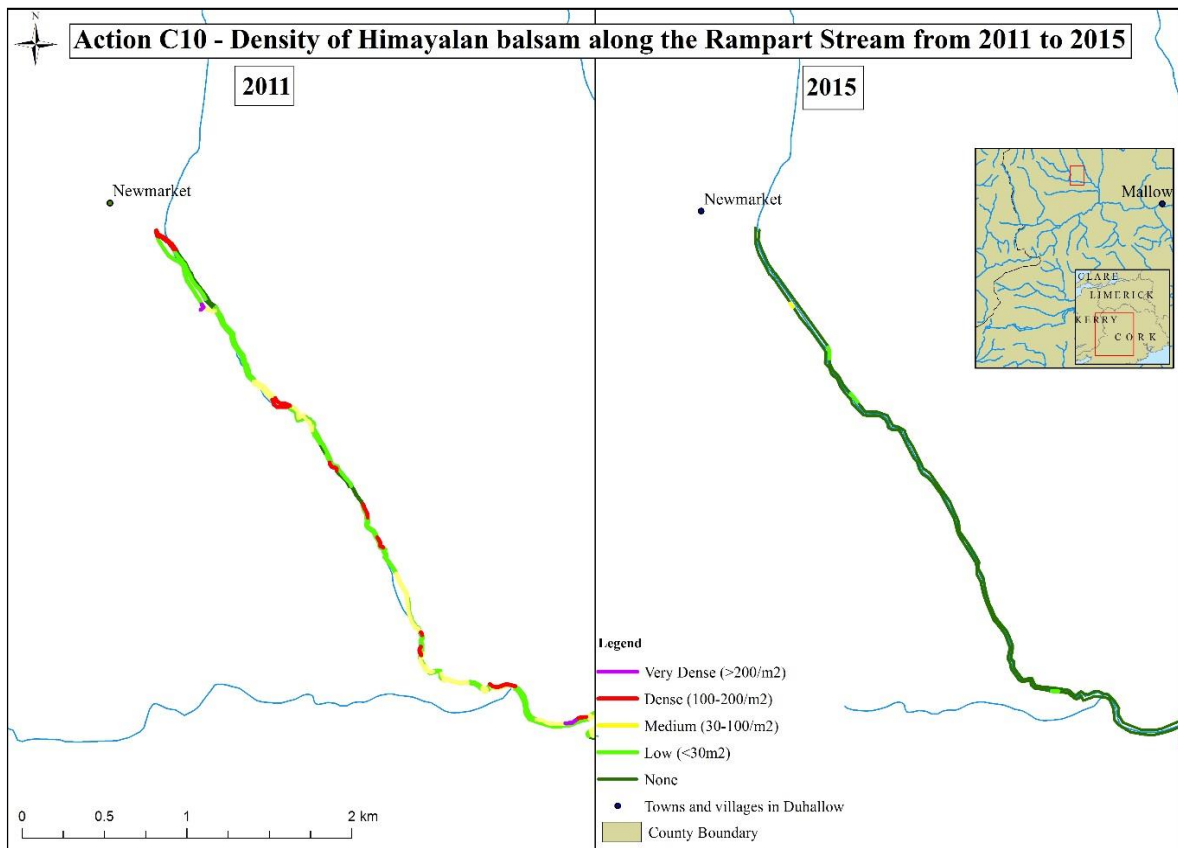
Figure 11 Distribution and densities (mean number of plants/m<sup>2</sup>) of *I. glandulifera* along the Rampart Stream in 2011 and 2015

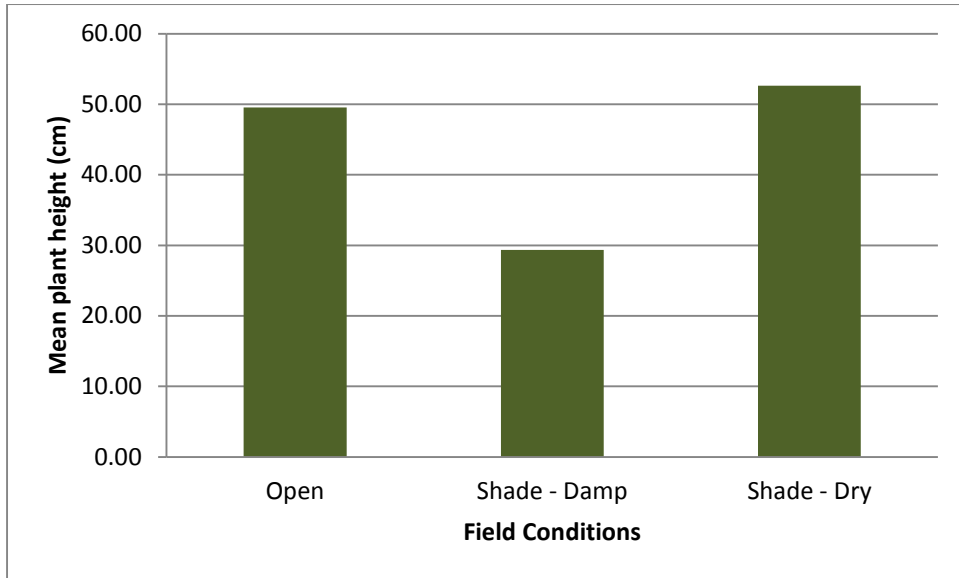
Figure 12 Mean heights of *I. glandulifera* recorded in three different field conditions: open ground (n=26; ITM: 532354, 606901), in damp shaded (n=26; ITM: 532080, 607351) and dry shaded (n=26; ITM: 532103, 607288). Trial site was located in Newmarket.

Results from the Newmarket trial site suggest that Himalayan Balsam in open ground conditions is more productive both in terms of the height of plants and the number of flower heads per plant, when compared with plants growing in shaded conditions; and that the species is more productive in shaded dry conditions than shaded damp sites.

Field surveyors and invasive species control crews noticed that there were significant on the ground variations in the development stages of *I. glandulifera* plants depending on the habitat where they occurred. Generally, it was observed that flowering (early June onwards) occurred earlier in plants growing in sunlit open field sites. Plants growing in more shaded locations and sharing space with other plants especially larger woody vegetation such as willow or alder, tended to flower later (July onwards). In heavily shaded areas, commencement of flowering did not begin until late August or early September. To examine this anecdotal observation further, the stage of development of plants growing under three conditions (open sun lit site, damp shaded site and dry shaded site) were examined. Ground wetness was also examined as

a variable as field staff believed that this may also have been relevant (Appendix 1: Figures 12 & 13).

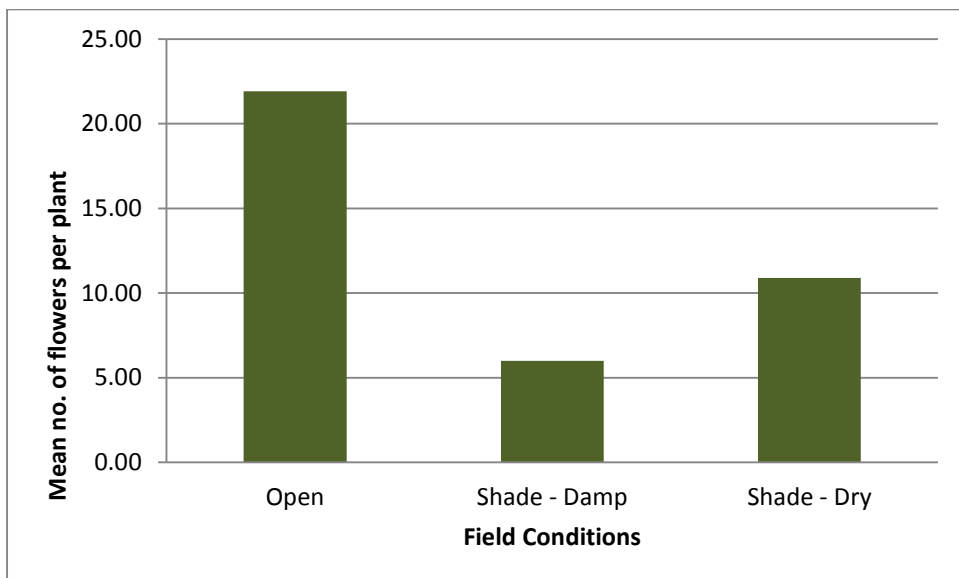
Figure 13 Average number of flowers per plant counted on *I. glandulifera* plants in three different field conditions: open ground (n=26; ITM: 532354, 606901), in damp shaded (n=26) and dry shaded (n=26). Trial site was located in Newmarket.
