**Rebalancing of riparian vegetation to address areas affected by  
excessive shading –  
Monitoring Report**

**Action C5**

**LIFE09 NAT/IE/000220 BLACKWATER SAMOK**

June 2015

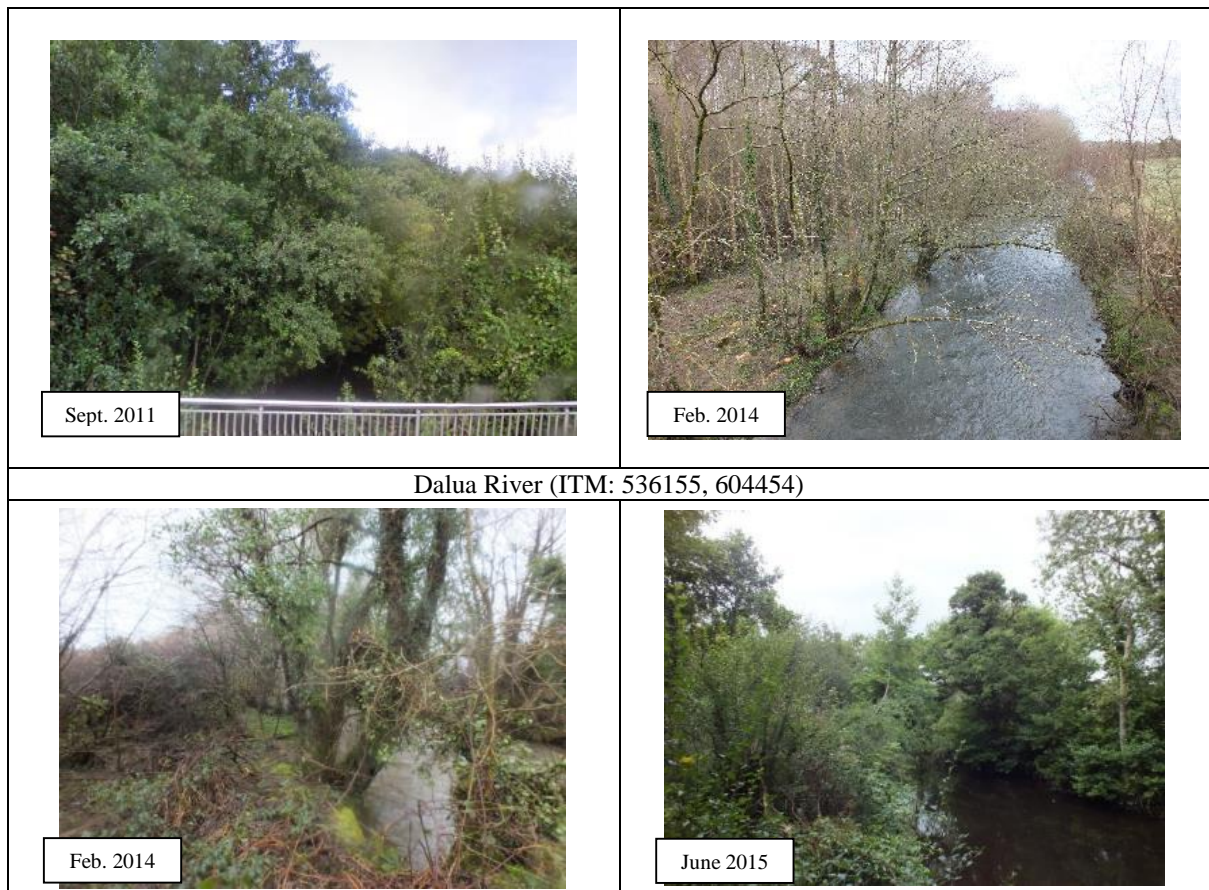
Table 1 Sites along the Allow, Dalua and Brogeen Rivers where coppicing and limbing were conducted (before and after).

Before	After
Allow (ITM: 539317, 610073)	
<p>May 2011</p>	<p>Feb. 2014</p>
Brogeen (adjacent to Kanturk Castle) (ITM: 538188, 601804)

In total, riparian tree pruning was carried out along 3.11km of a 6.46km length of river bank (Figure 2). The before and after photos (spanning a 3-year period from 2011 to 2014) show the extent of trees and branches removed from the banks of the Allow, Brogeen and Dalua Rivers (Table 1). The selective removal of trees and shrubs can result in a dappled effect that allows light to penetrate the water. This encourages photosynthesis of macrophytes while keeping temperatures low (Forest Service, 2000).

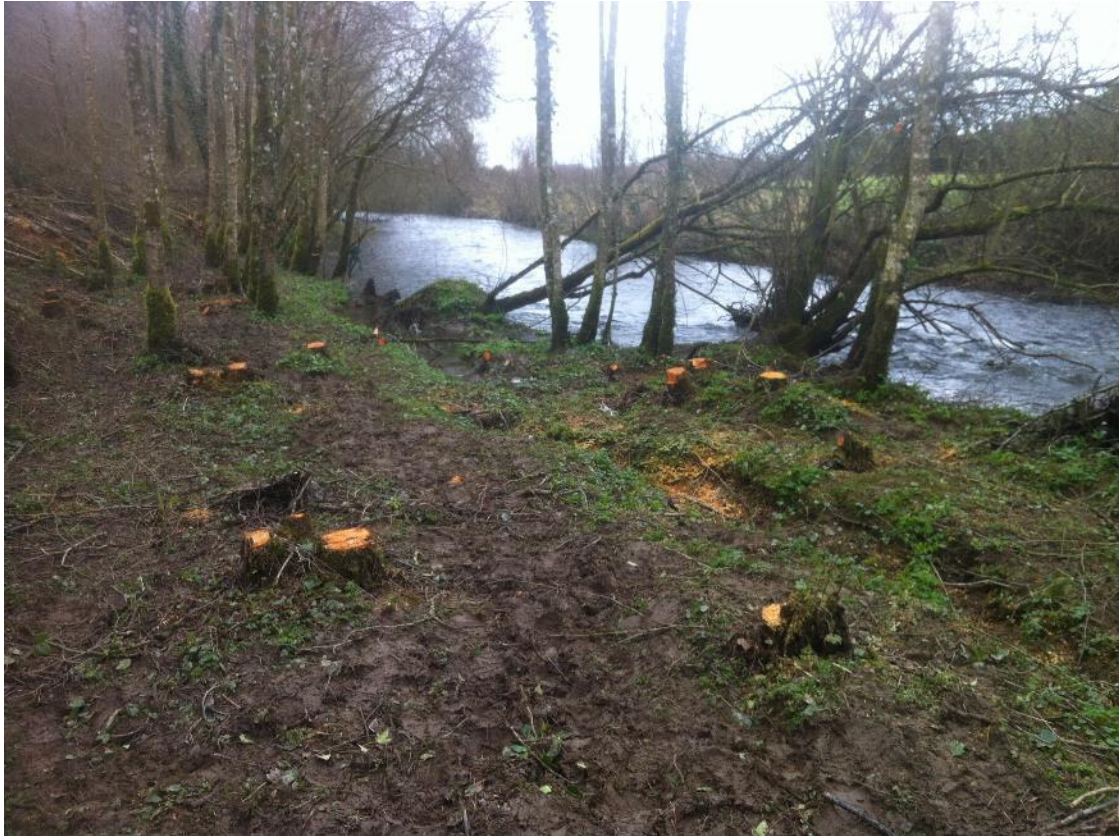
Figure 3 Bankside view of coppiced and removed trees along the Brogeen

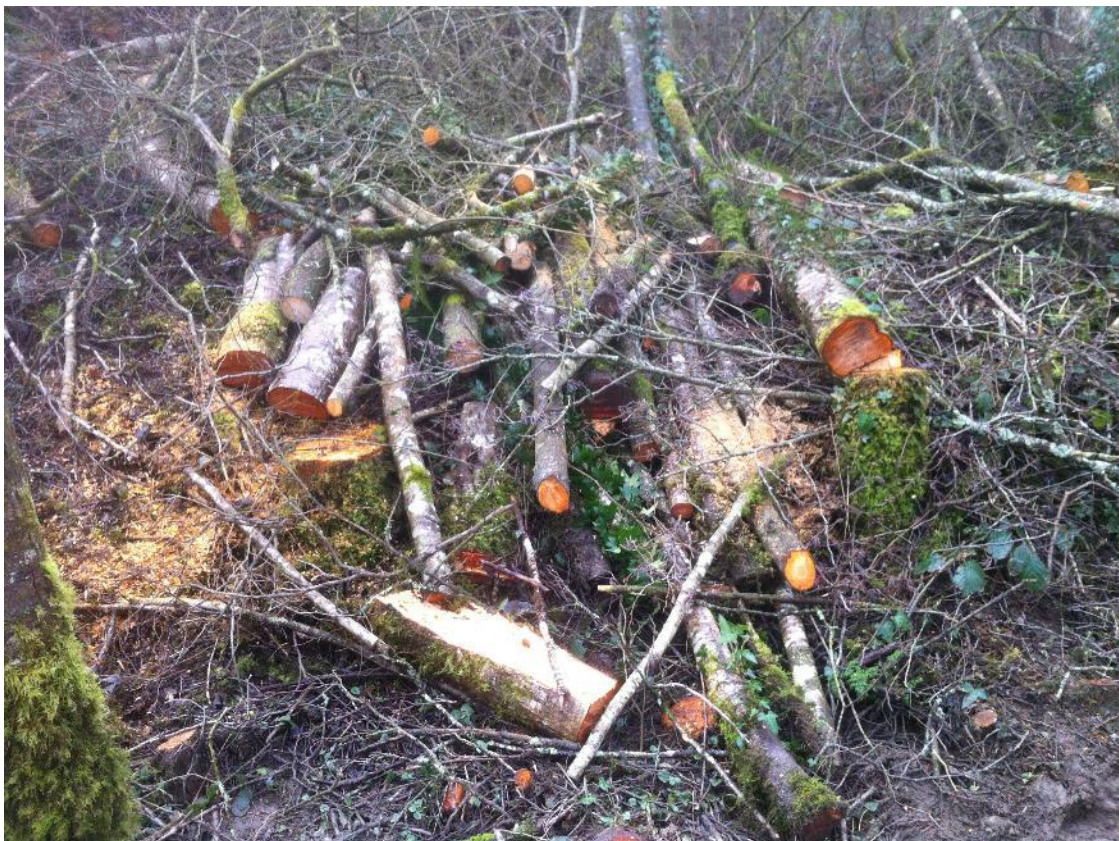
Figure 4 Trees cut down in the process of Action C5 were stockpiled and used to construct log piles for Action C7

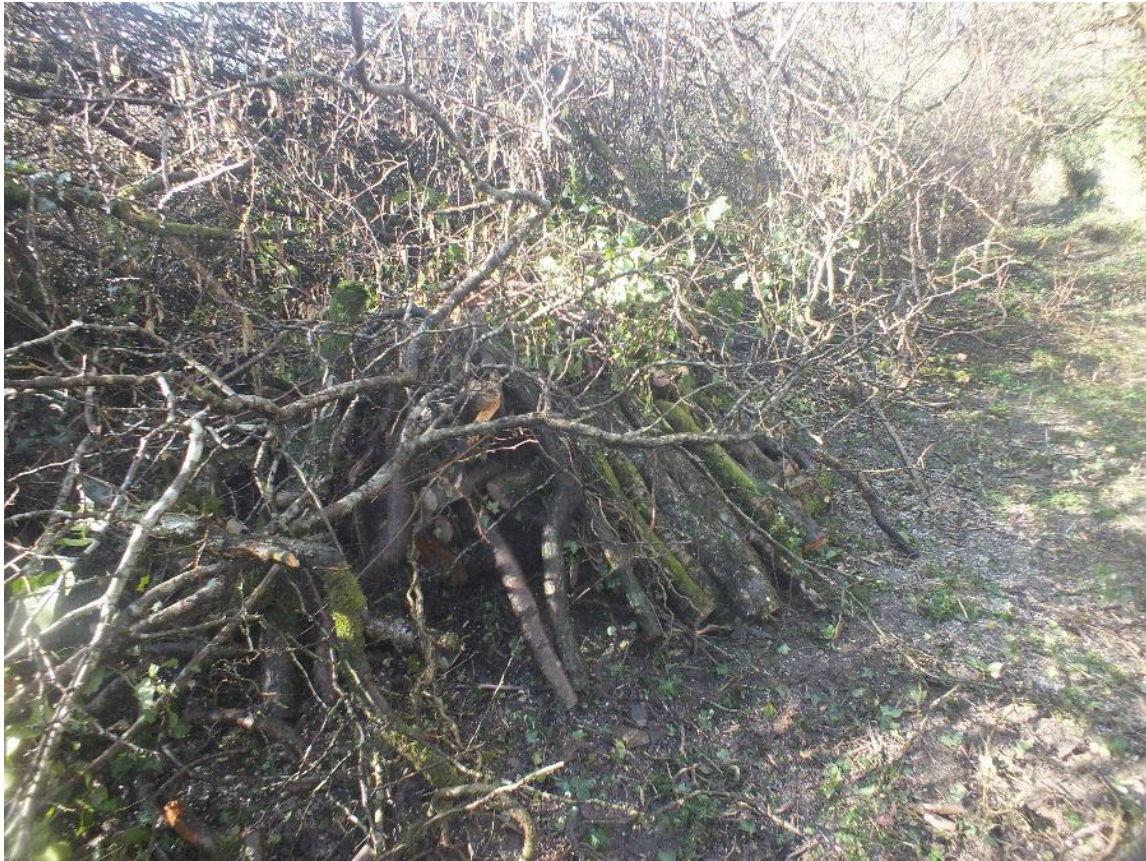
Figure 5 Otter log pile (Action C7) built with timber cut-offs from Action C5

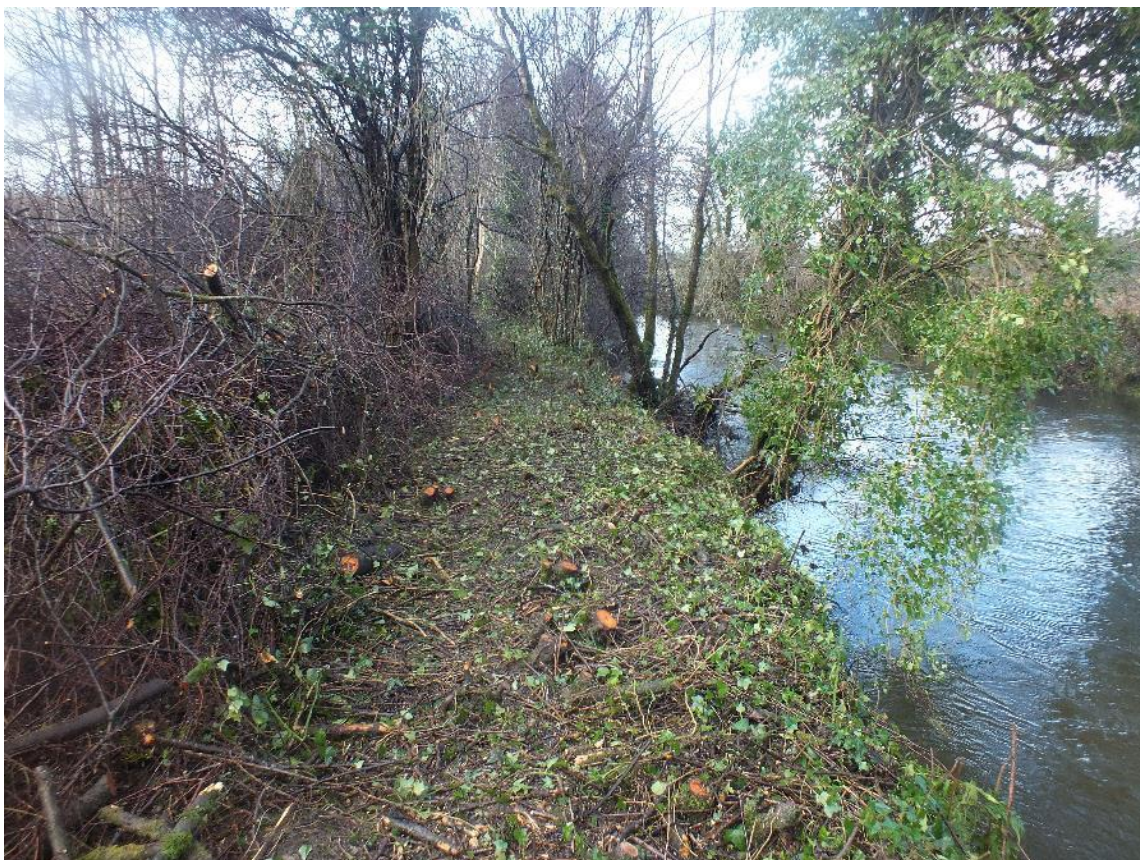
Figure 6 Bankside view of removed trees along the Dalua River

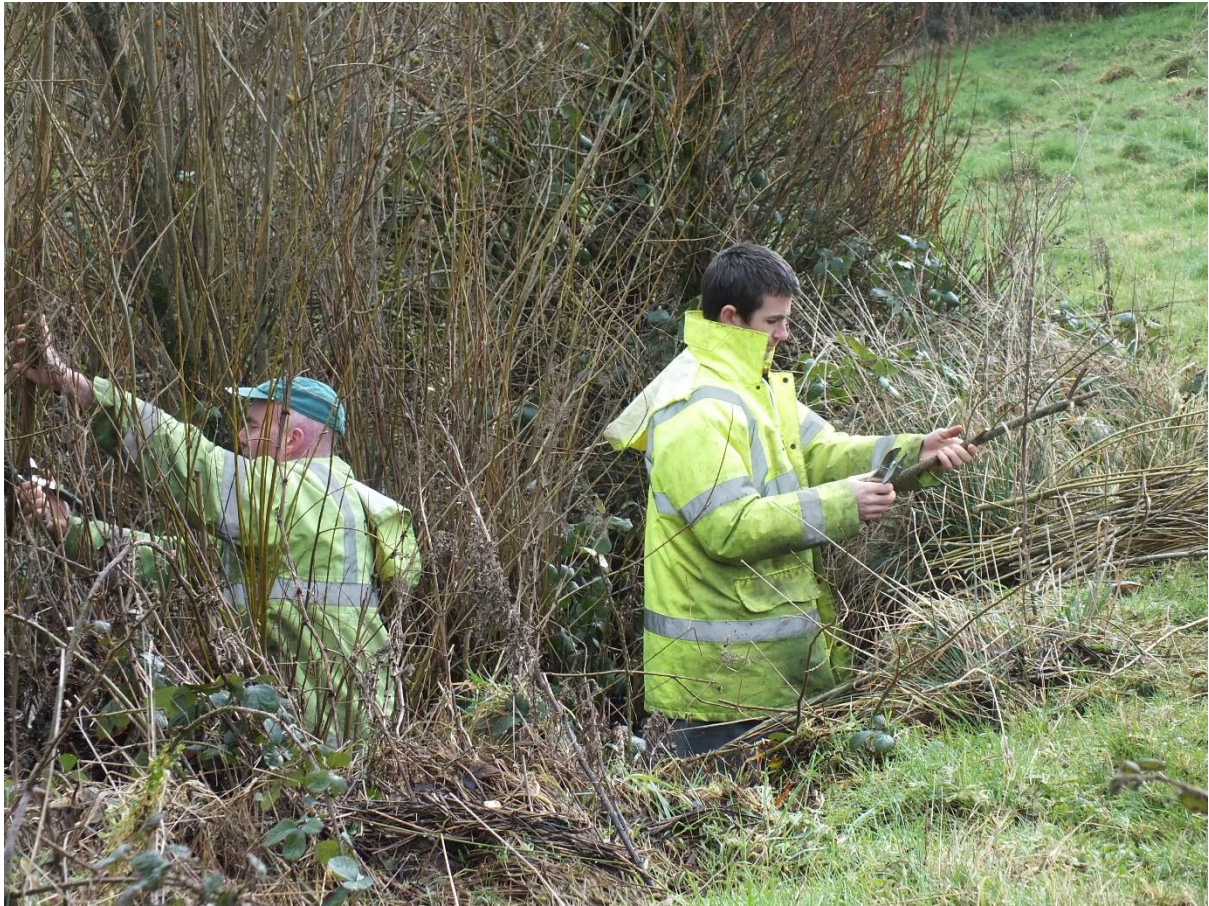
Figure 7 Pruned tree limbs were collected and used for Action C6

A lot of the works carried out with regard to reducing over-shading were pre-emptive. Willow trees planted by DuhallowLIFE and Inland Fisheries Ireland (Gillespie, 2015) run the risk of over shading and blocking the river. Pruning the limbs of these willows reduced this risk as well as providing slips and stakes for planting elsewhere in the catchment.
