**Provision of Nesting Sites and Nest Boxes for  
the European Kingfisher (*Alcedo atthis*) and  
the Irish White-Throated Dipper (*Cinclus  
cinclus hibernicus*) along the River Allow**

**Prepared by Kieran Murphy (April/May 2011)**

**I.R.D. Duhallow Ltd.**

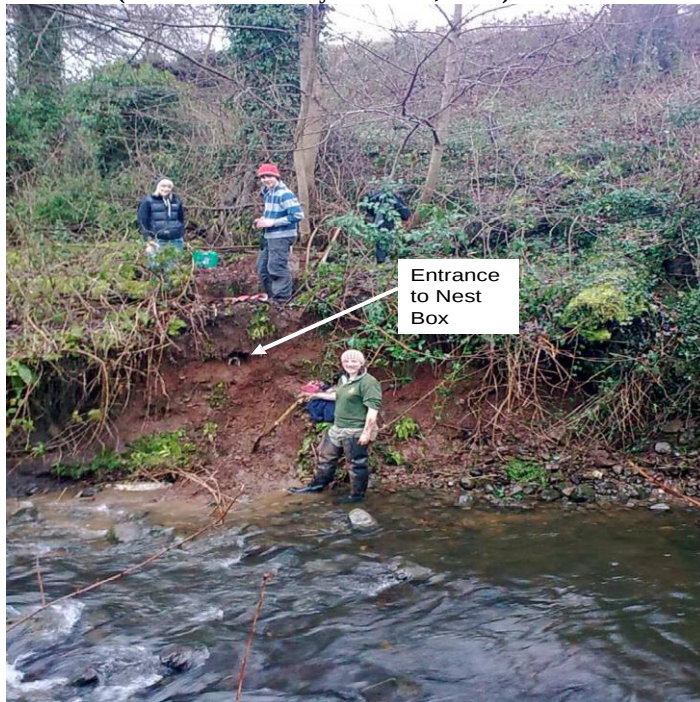
Picture 2 (RSPB Community – LVRP, 2011)

A small trench should be dug so that the roof of the tunnel and nest chamber is at least 300mm (1 foot deep) below the top of the bank and it should be 1 metre long and at least 300mm wide. Before the chamber and tunnel are covered again, bank material (sand, clay, etc.) should be lightly packed into them, all the way up to the entrance. This is to ensure that the kingfisher will have something to excavate. Also, the chamber end of the object should be slightly higher than the entrance so that the entire nest box is angled to at least 15°. The entrance of the tunnel should be in about 100mm from the face of the bank. This makes sure that the artificial material does not becoming obvious in the event of bank material falling away (De Feu, 1993) (See Picture 2, 3 and 4).

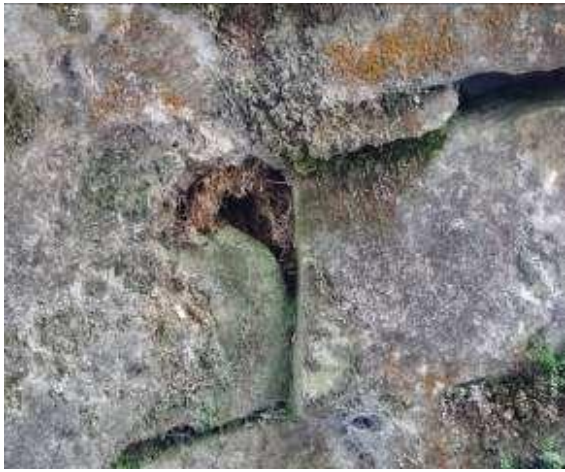
Picture 5 – Dipper nest Ballynaguilla Br. (K. Murphy) Picture 6 – Dipper nest ‘Metal’ Br. (Dr. F. Igoe)

The nesting requirements of this bird are basic, relative to those of the kingfisher. Dippers will nest in crevices of large rocks, disused drainage pipes, ledges and underneath bridges (see Picture 5 and 6). It is the latter that is a cause of some concern at present. With the restoration of many old bridges, for safety and infrastructural reasons, many points underneath these bridges, where the dipper previously nested at are being lost. Older bridges often contained irregular brickwork that would have provided ledges and crevices, and support beams higher up, all of which gave plenty of nesting sites (Tyler & Ormerod, 1994, cited by Copland, 2007). The improvement in infrastructure and building methods have now made these features a thing of the past (Copland, 2007). To address this issue the I.R.D. Duhallow LIFE Project has set out a plan (Action C9) to set up special nesting sites to be established beneath 10 bridges that occur along the Allow (Fig.2 for locations of bridges).

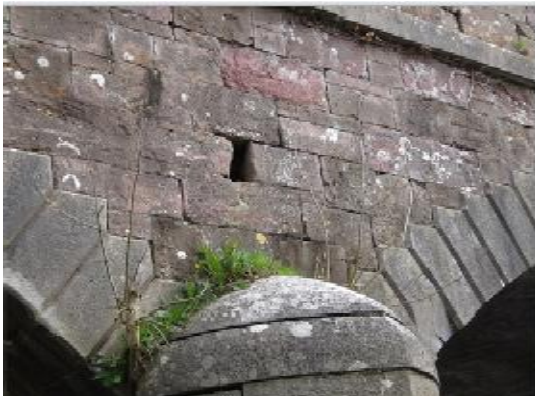
**Photo 1**

A missing brick in between the two arches on the downstream face of the bridge has the potential of nesting many species of bird (See Photo 1). If it was already occupied the chances were that a bird other than a dipper had nested there. Dippers prefer to nest from where they can easily 'fall' into the water if feeling threatened so this hole must have been unsuitable. Also, no suitable holes were found under the archways for neither dipper nor grey wagtail (*Motacilla cinerea*)

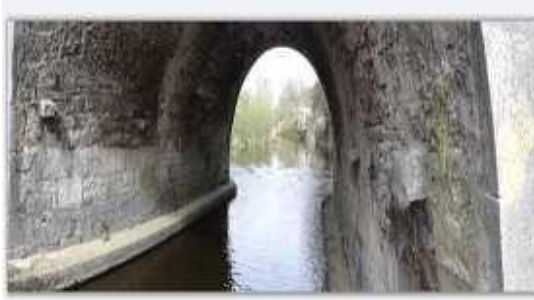
**Photo 2**

Under each archway there were many outcrops of brick that could be considered suitable nesting sites for the dipper (See Photo 2). Each ledge, however, was absent of any bird activity. This may be because they were at chest height and easily accessible for human interference. The river itself at this site is actually very accessible for people and it is possible that the dippers in the area know this and stay away.

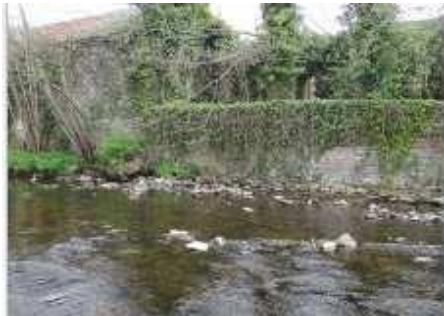
**Photo 3**

A good reason why no dipper nests were found under either bridge could be because there were plenty of potential sites along the river as the banks were walled and may have holes, crevices and ledges that are big enough to hold nests (Photo 3).

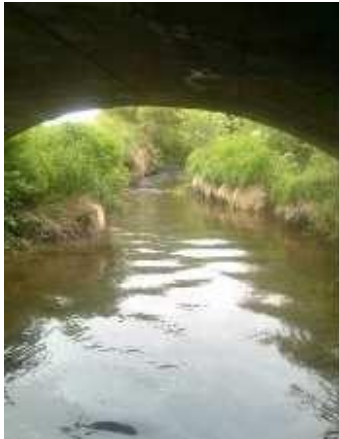
**Photo 4**

The underside of this single span bridge is too close to the very shallow water for be used as a site for nesting dippers (See Photo 4). Also, the underside of bridge is not suitable for natural nesting.

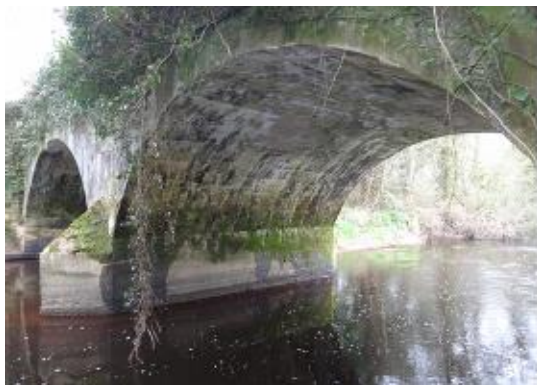
**Photo 5**

The underside two spans of the bridge showed no evidence of potential sites for natural dipper nests. Ivy overgrowth of the downstream (southerly) facing façade may hold suitable cover for the dipper (Photo 5). High activity of a blue tit (*Parus caeruleus*) on the day of surveying (08-04-11) suggested that the tit was defending a nest from the surveyors and it is likely, therefore, that no other passerine nest was in the ivy. Upstream of the bridge had quite suitable hunting grounds.

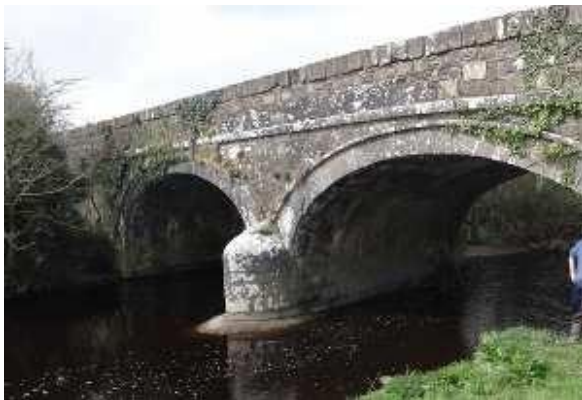
**Photo 6**

Deep waters underneath the double masonry span bridge are preceded by shallow riffles (Photo 6). This may make suitable habitat for the dipper. The masonry on the underside looked to be improved leaving no suitable nesting sites. No nests were observed.

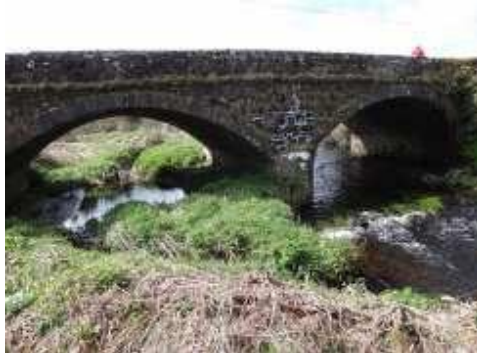
**Photo 8**

The stream over which the double masonry span bridge is built looked to be ideal dipper habitat. Possible dipper nest present but most likely grey wagtail. Size and shape of nest could not be seen as it was within a cavity. It did not seem to have the typical entry hole of a dipper nest (Photo 7). Bird droppings were observed. Dipper was seen flying overhead which may indicate that the area is inhabited by dippers. Sedimentation under one of the spans may lead to less suitable feeding grounds for both dipper and wagtail in the future (Photo 8).

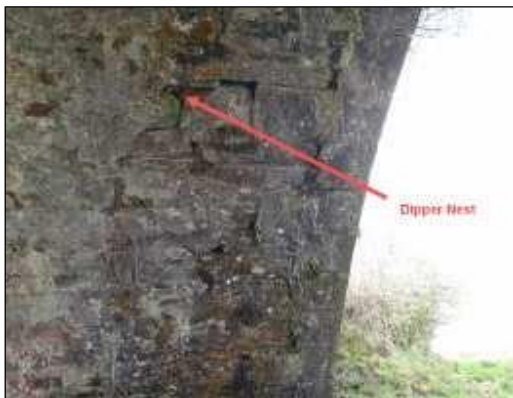
**Photo 9**

The single masonry span bridge did show signs of past maintenance. However, some crevices and holes were spotted. In one such hole was a dipper nest (Photo 9). The other cracks and crevices seemed too close to the dipper nest to make it comfortable with other species nesting there.

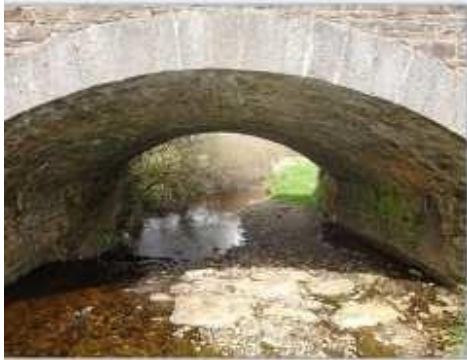
**Photo 10**

This single masonry span bridge showed no ‘natural’ nesting site for dippers or grey wagtails as the brick work seemed to be well maintained (Photo 10). There were signs of bird activity underneath the archway in the form of droppings.

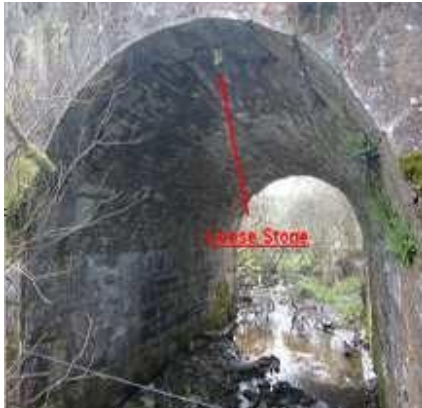
**Photo 11**

The single span masonry arched bridge had a stone loose near the apex of the arch (Photo 11). Inside was a dipper nest (Photo 12). At this youthful stage in the river the water would be fast moving and well oxygenated, again making for a good habitat for the dipper.

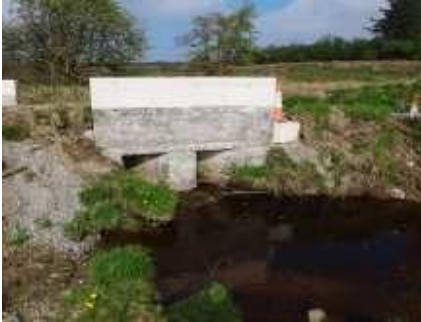
**Photo 13**

Double span concrete bridge proved unsuitable for dipper nesting (Photo 13). Water under the bridge looked to be too shallow and the arches too narrow to place a viable nesting box/ledge for the dipper (Photo 14). Also, current human activity around the bridge might also deter any nesting bird.

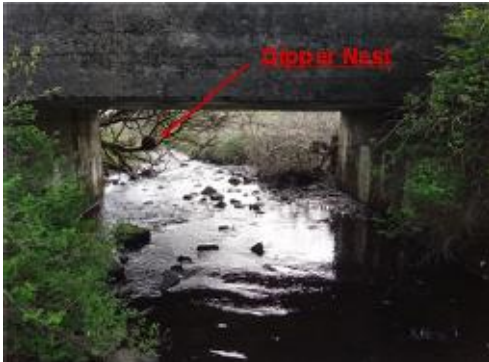
**Photo 15**

The habitat around this single concrete span bridge looked to be ideal for foraging dippers. The bridge itself had no place for dippers to nest but this proved to be unnecessary as there was a nest in the fork of an over hanging branch (Photo 15). A dipper was also sighted in the vicinity of the nest.

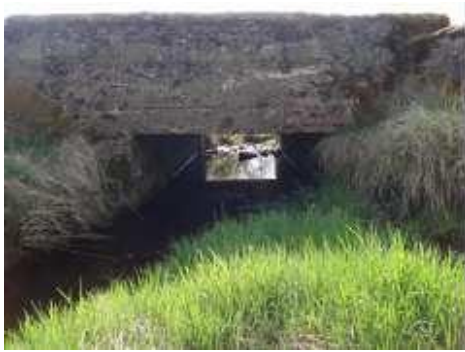
**Photo 16**

There was nowhere suitable for natural nests under this single span concrete bridge. Bridge seemed quite low also (Photo 16). Habitat looked to be very suitable though.

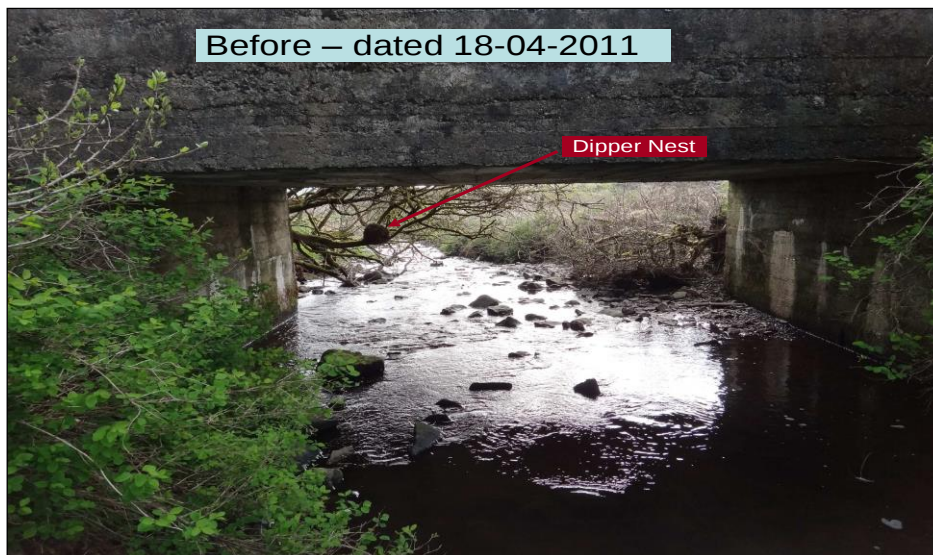
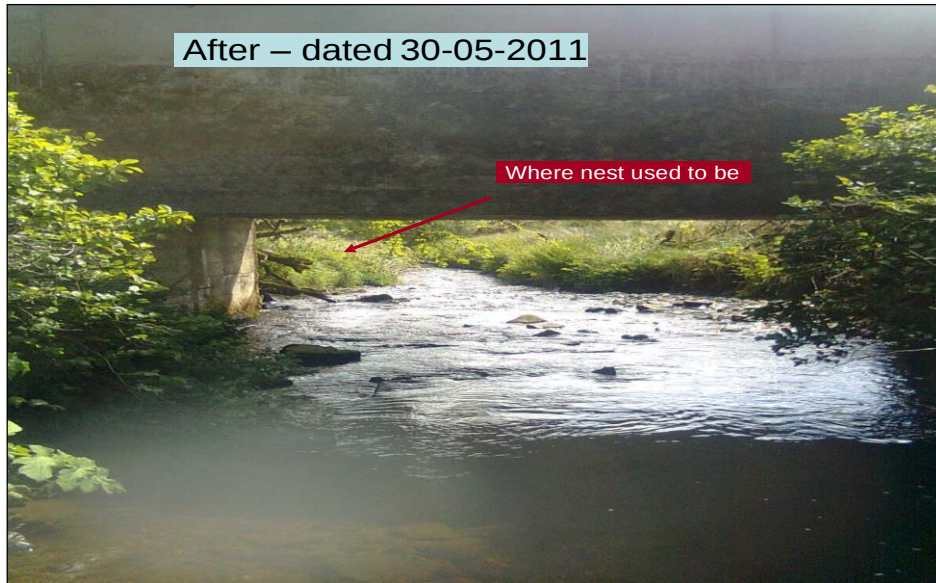
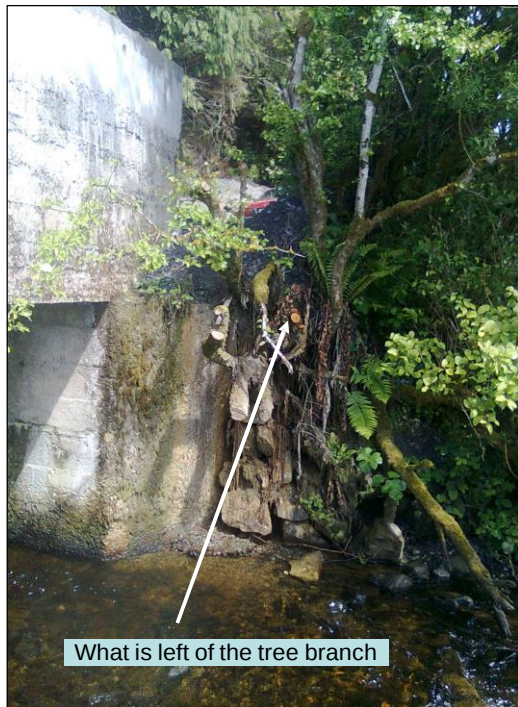
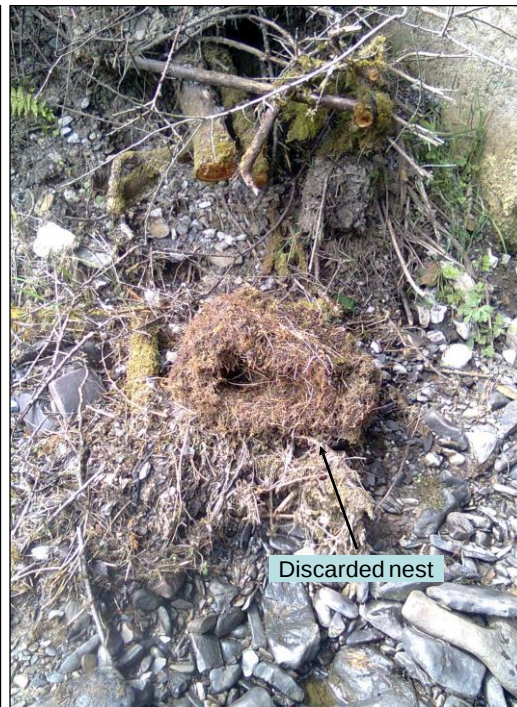
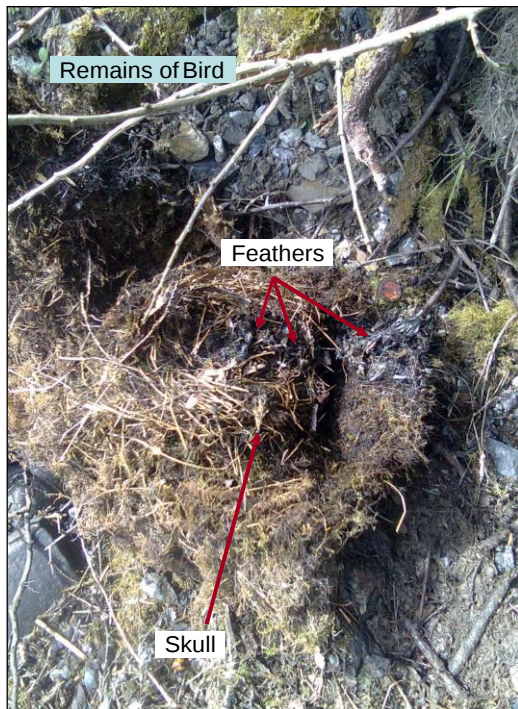
**\*\*Since this survey was done and the dipper nest identified, the branch upon which the nest was situated was "illegally" cut down was discarded. On inspection the remains of a young bird was found within what was left of the nest. See photos 17-21 (inclusive) in Appendix.**

When surveying bridges (18<sup>th</sup> of April) on the River Allow for potential sites to install artificial nesting units for the dipper, a nest was located in the fork of a tree that overhung the river less than a metre downstream of the bridge (Photo 17). At a later date (30<sup>th</sup> of May) this nest was found to have been discarded and the branch upon which the nest was sitting was cut down (Photos 18-21 incl.). It is because of this disregard that the installation of nest units is important to give dippers a chance to fledge and mature.
