Reduction and elimination of trampling and soiling of river by cattle by fencing vulnerable river bank sections

- Monitoring Report

Action C2

LIFE09 NAT/IE/000220 BLACKWATER SAMOK

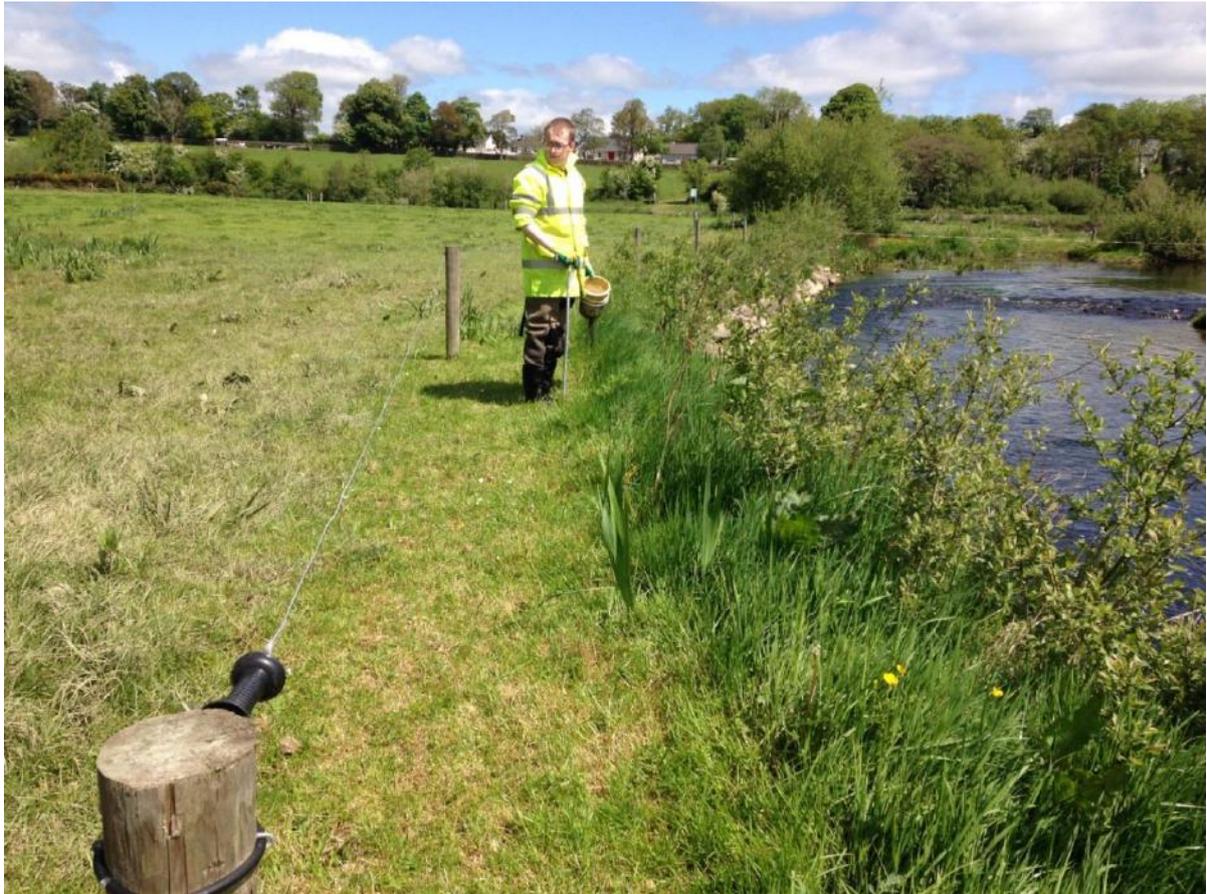
Figure 3 Cattle can graze beyond the fence line showing the importance of establishing a fence line at least two metre from the top of the riverbank.

Establishing a single strand fence line at least 2m from the top of a riverbank facilitates the regeneration of a riparian buffer. It also allows for grazing beyond the fence line without severely impeding on natural regrowth (Figure 3). Previous agri-environmental schemes (e.g. Rural Environment Protection Scheme) allowed for a fence line of at least 1.5m from the top of the bank to protect riverbanks from overgrazing and poaching. While this can prevent livestock from accessing the top of the riverbank, it can also lead to soil poaching and resultant sedimentation of the riverbed. It also prevents plants from developing sufficient root length (Tables 1 and 2, $p < 0.05$) and mass, which lessens their capacity to hold banks together and filter surface runoff (Hoorman and McCutcheon, 2005). For this reason, DuhallowLIFE convinced farmers to allow the project to erect fencing at least 2m back from the top of the riverbank.

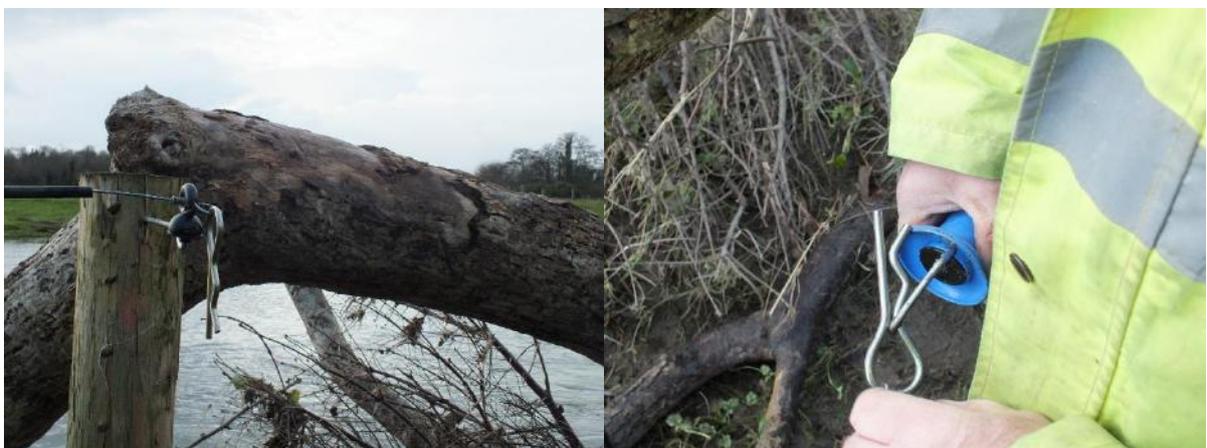
Figure 4 Fencing wire after detaching from the post after coming under pressure for a large debris carried by floodwaters (left), and reattaching the fencing wire after floodwaters have dissipated (right).

A project innovation now makes it possible to fence flood prone areas, previously not possible to fence due to entrainment of large debris. Instead of fencing wires snapping under the pressure of large debris carried by high floodwaters, break points have been installed at strategic locations along fence lines in the Allow, Dalua and Brogeen rivers. The break points proved successful during the large floods of 2014, with no loss of project fencing (Figure 4).

Prior to the project it was not possible to fence in some locations. This project pioneered a flood friendly fencing technique that releases the excessive pressure caused by debris build up on the fence line. This was developed by the LIFE Project team in partnership with local farmers, and was tested on the River Dalua. With guidance and advice from landowners and consultant engineers, the sections of fences most vulnerable to flood damage were identified and a quick release system at each pressure point was developed (Figure 2). Under significant pressure the handle and clip would come apart. Once the flood has passed the two parts are easily reconnected.

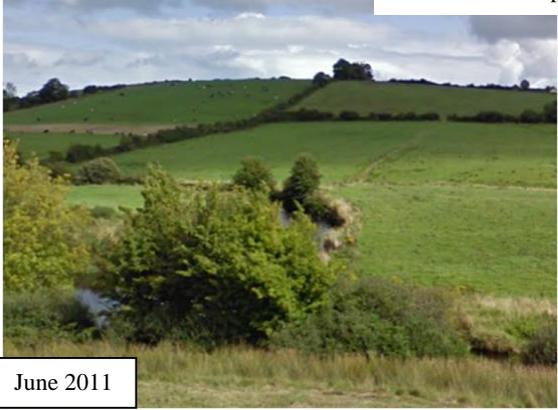
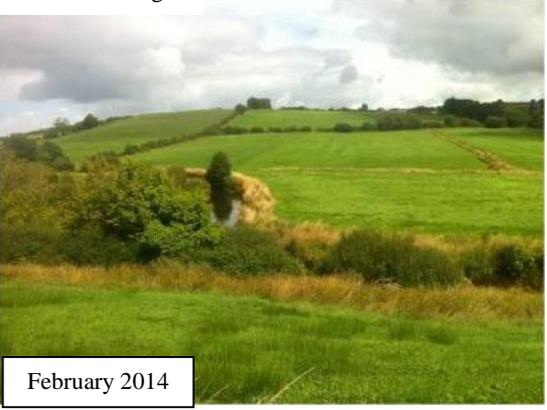
Before Fencing	After Fencing
River Allow - Upstream of Metal Bridge

Table 4 Riverbank sections before and after fencing by LIFE Project. All fence posts were erected at least 2m from the top of the riverbank.

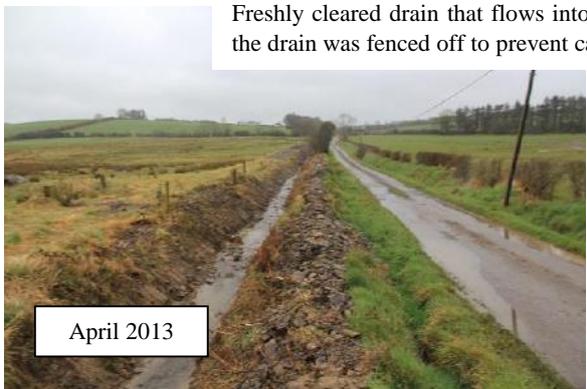
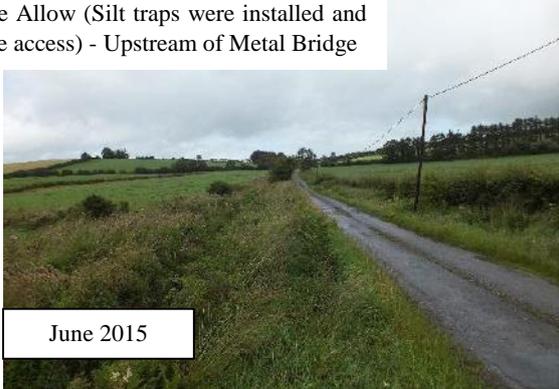
Freshly cleared drain that flows into the Allow (Silt traps were installed and the drain was fenced off to prevent cattle access) - Upstream of Metal Bridge
